**REVIEW OF THE
HARRINGTON GRIST MILL**

HARRINGTON, ONTARIO

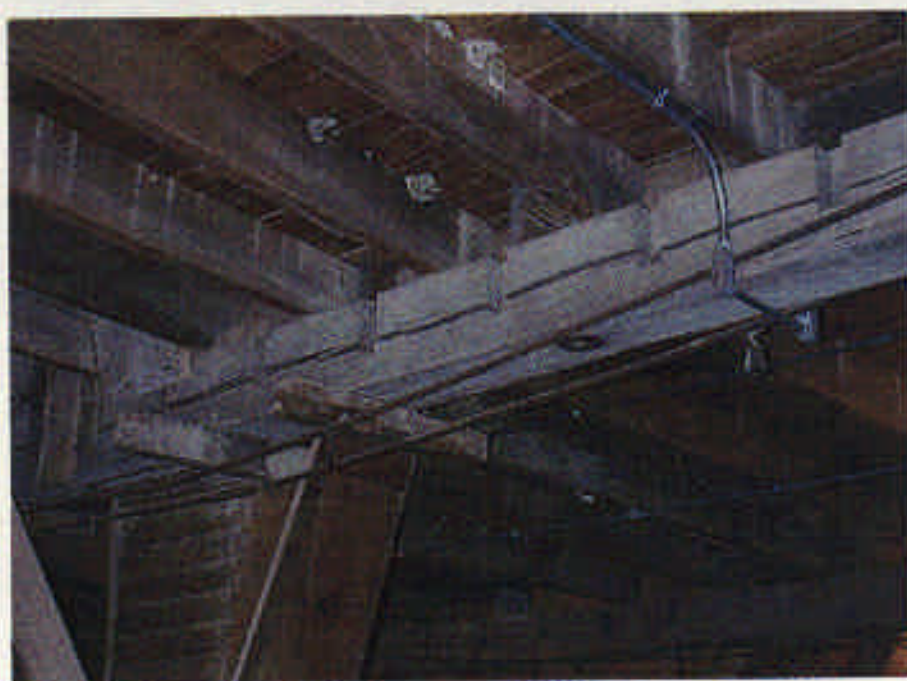
Photograph 4: Large crack in existing beam. Note the steel reinforcing rod in the existing beam.

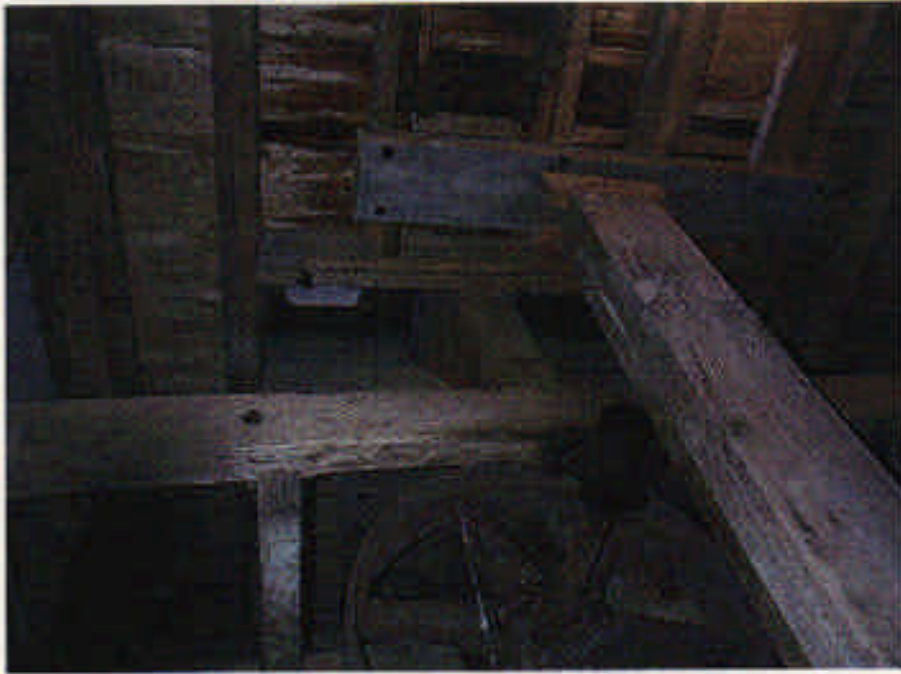
Photograph 5: Additional column and framing in the hopper area.

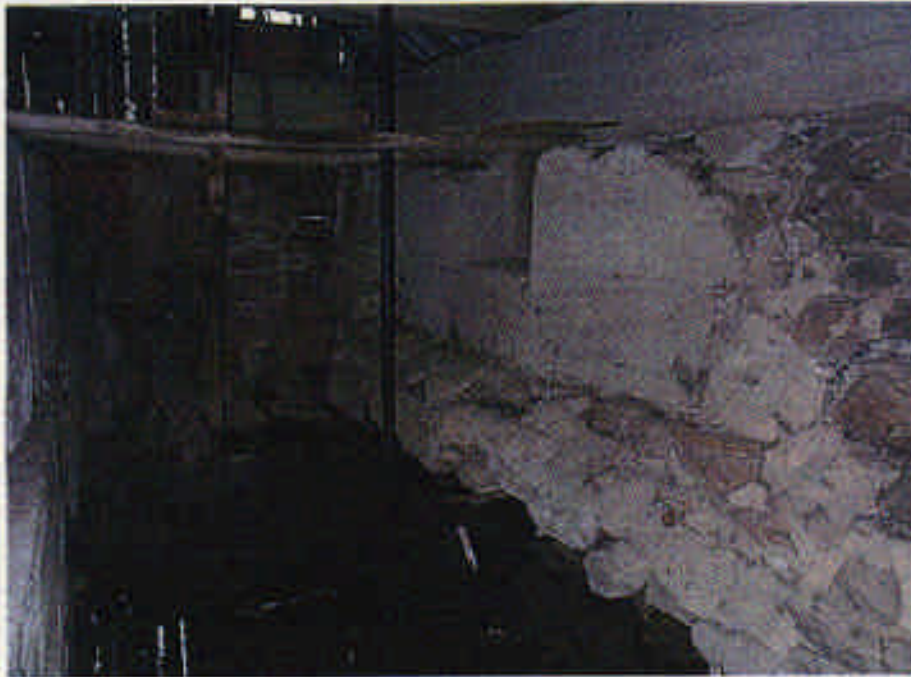
Photograph 8: Foundations consist of a combination of concrete and rubble stone.

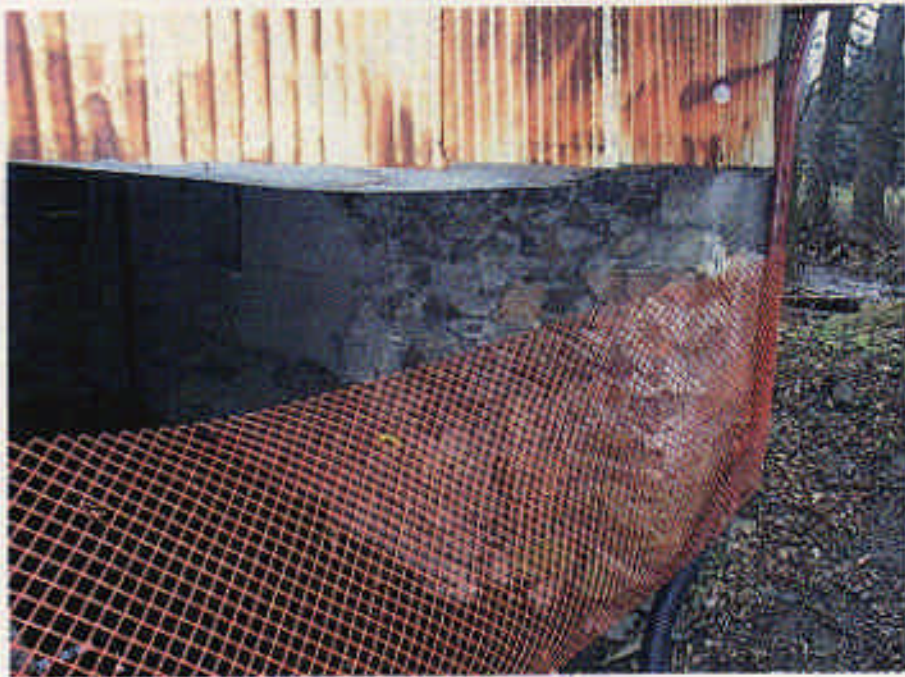
Photograph 9: Partial collapse of the rubble stone foundation in the spillway.

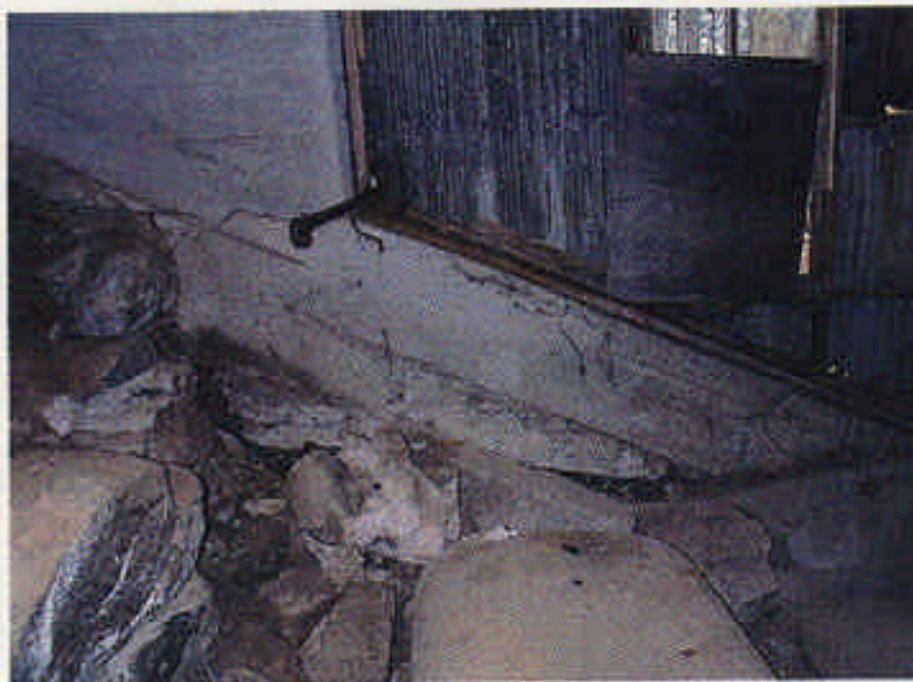
Photograph 10: Crack in existing concrete foundations. Note the loss of bearing under the footing indicating large footing movements.

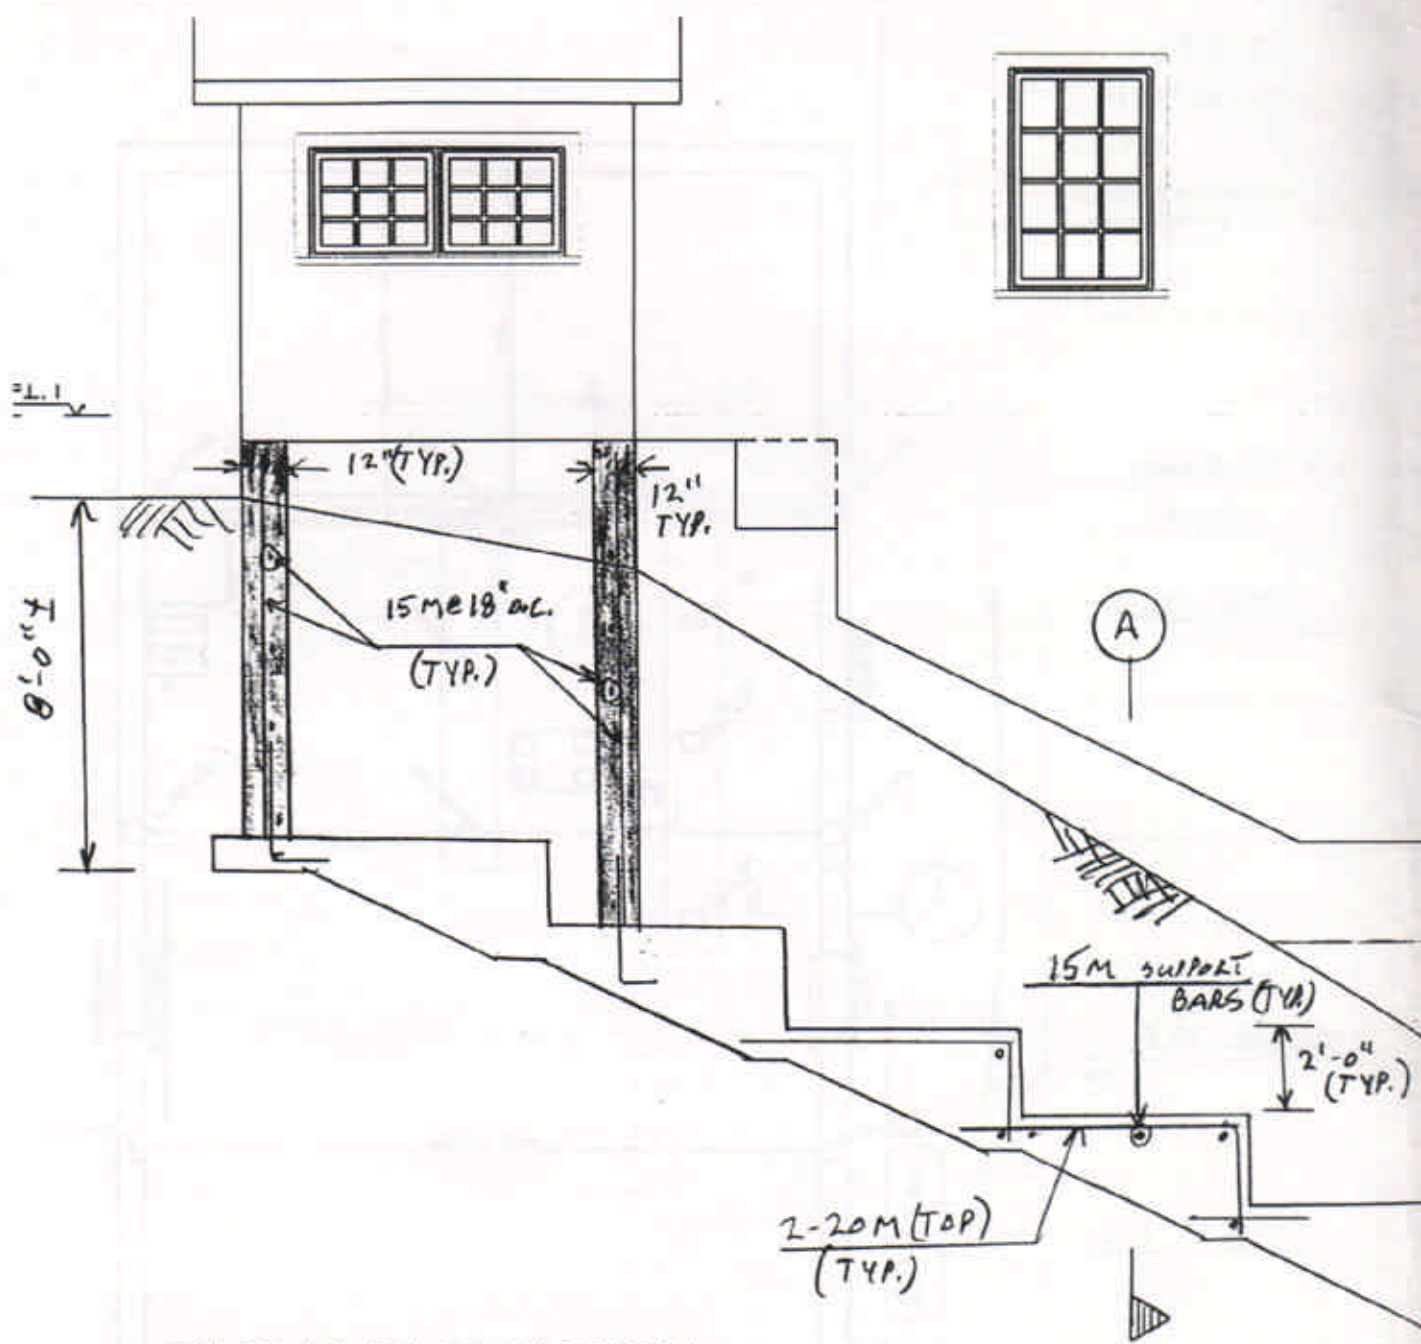
RIGHT ELEVATION
 SCALE: 1/4" = 1'-0"

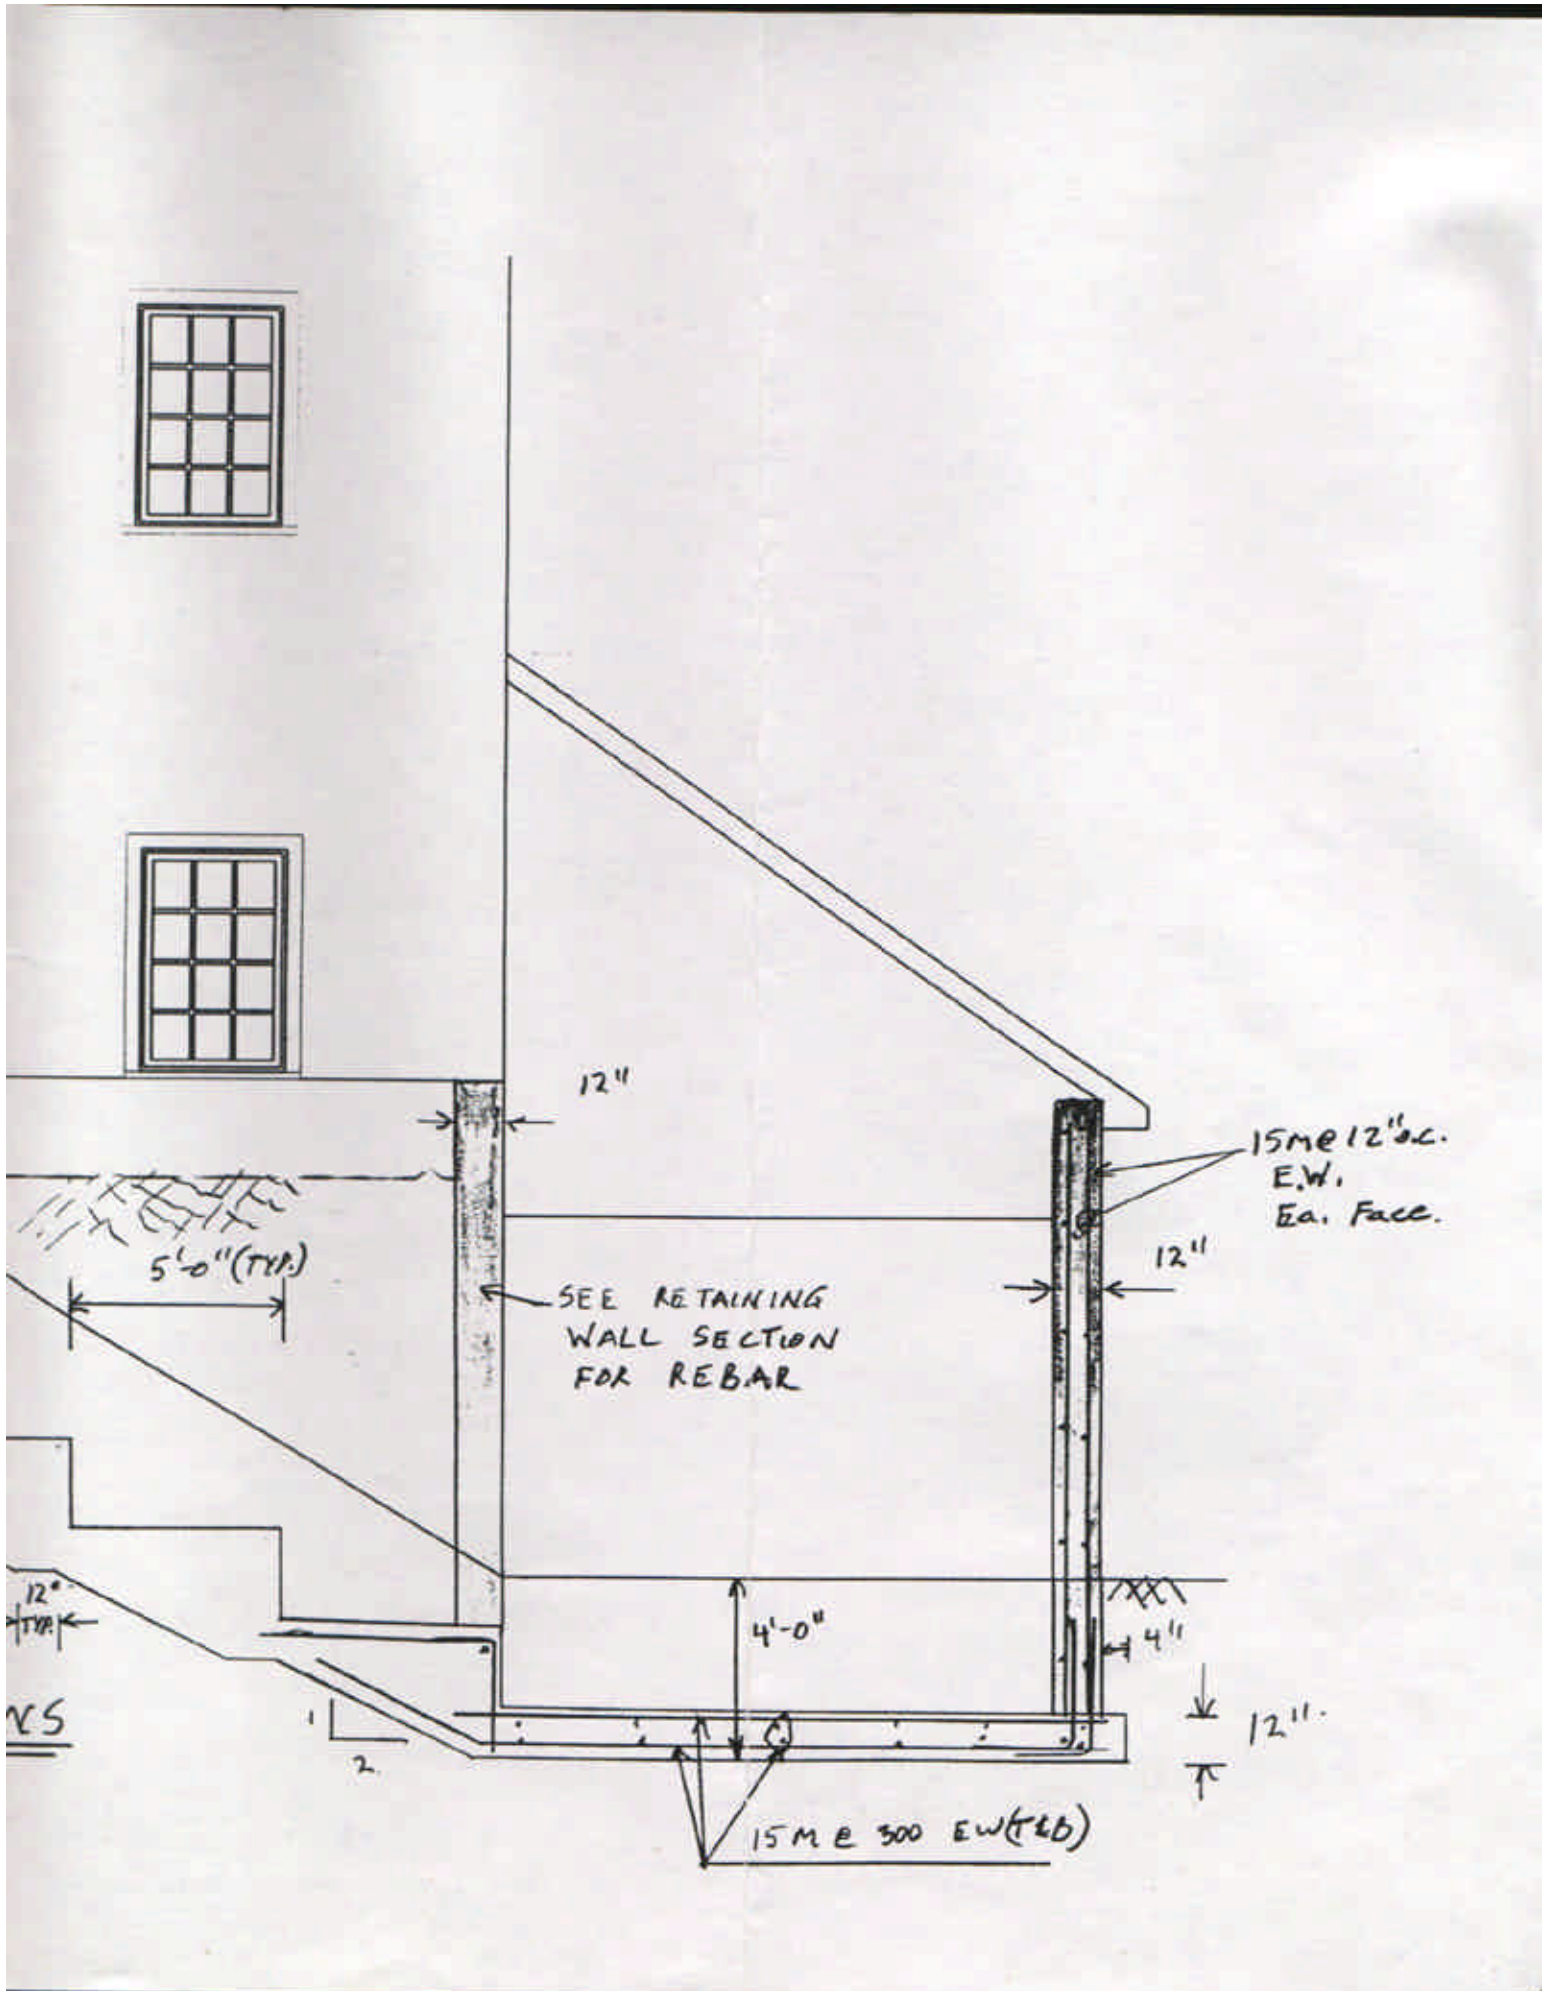
SK-1
 APRIL 26, 2002
 page 1 of 4
